Arizona Building Dust
Tucson Civic Center Non-Attic
Environmental Forensic Microscopy Analysis

**Arizona Building Dust – Civic Center Non-Attic Samples
Environmental Forensic Microscopy Analysis**

Arizona Building Dust
Tucson Civic Plaza Exhibit Hall
Environmental Forensic Microscopy Analysis

**Arizona Building Dust – Tucson Civic Plaza Exhibit Hall
Environmental Forensic Microscopy Analysis**

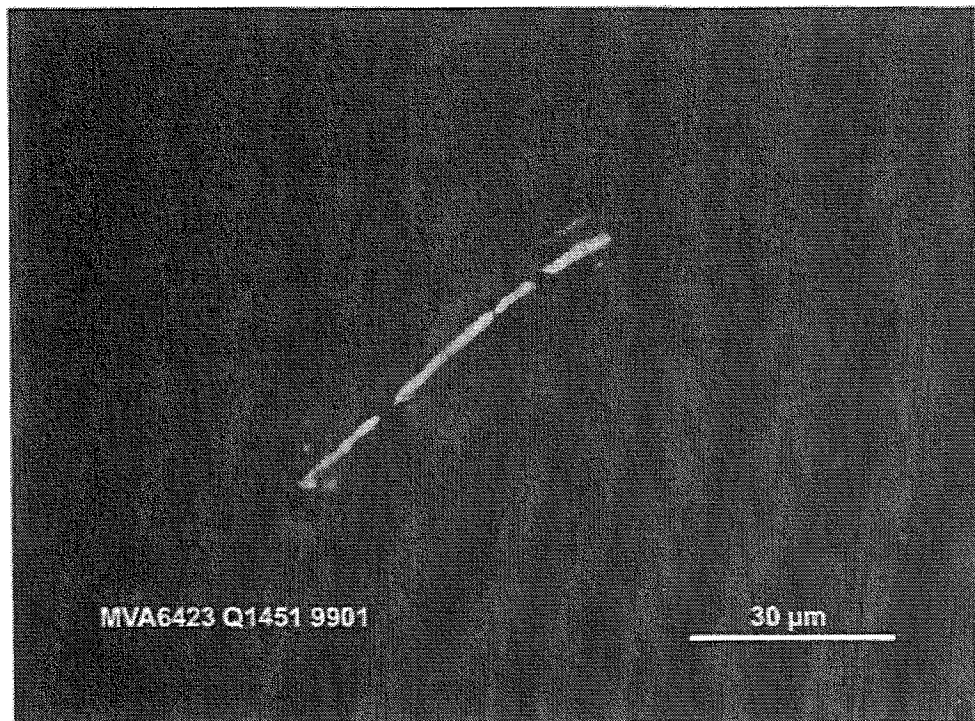
The dusts in Samples Q1448 through Q1451 have the same appearance. They are all fine granular dusts, gray in color with evident fibers. They contain vermiculite, gypsum and chrysotile asbestos (Figures 1 through 3). The particles in the dusts are consistent with normal indoor building dusts^{1,2} (including cotton, plant fragments and other fibers) mixed with fallout from the fireproofing (containing vermiculite, gypsum and chrysotile) that is located in the building.

Figure 1. Polarized light microscope image (darkfield mode) of a chrysotile bundle among gypsum and vermiculite flakes in Sample Q1451

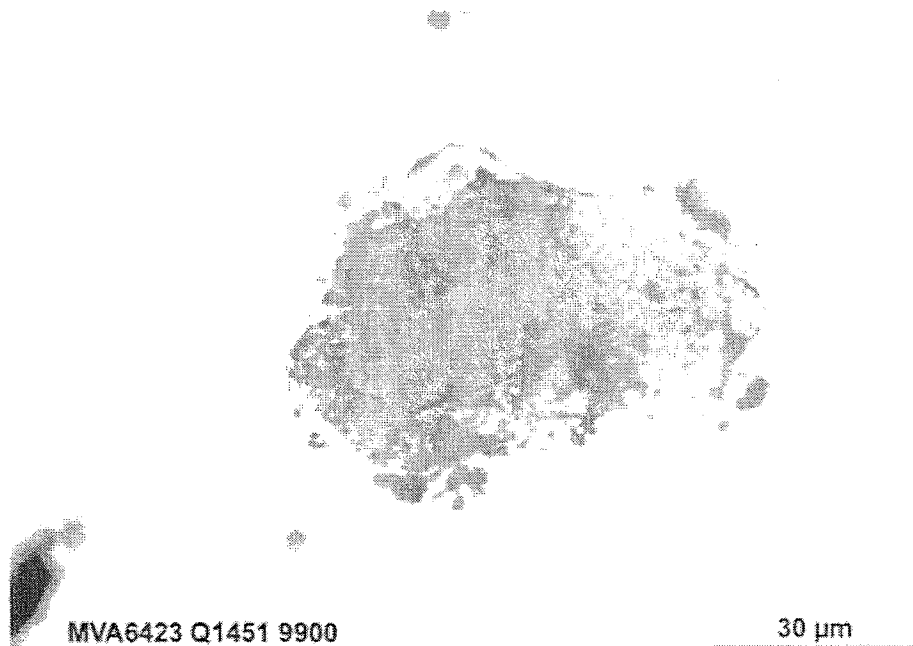
Figure 2. Polarized light microscope image (brightfield mode) of a vermiculite flake in Sample Q1451.

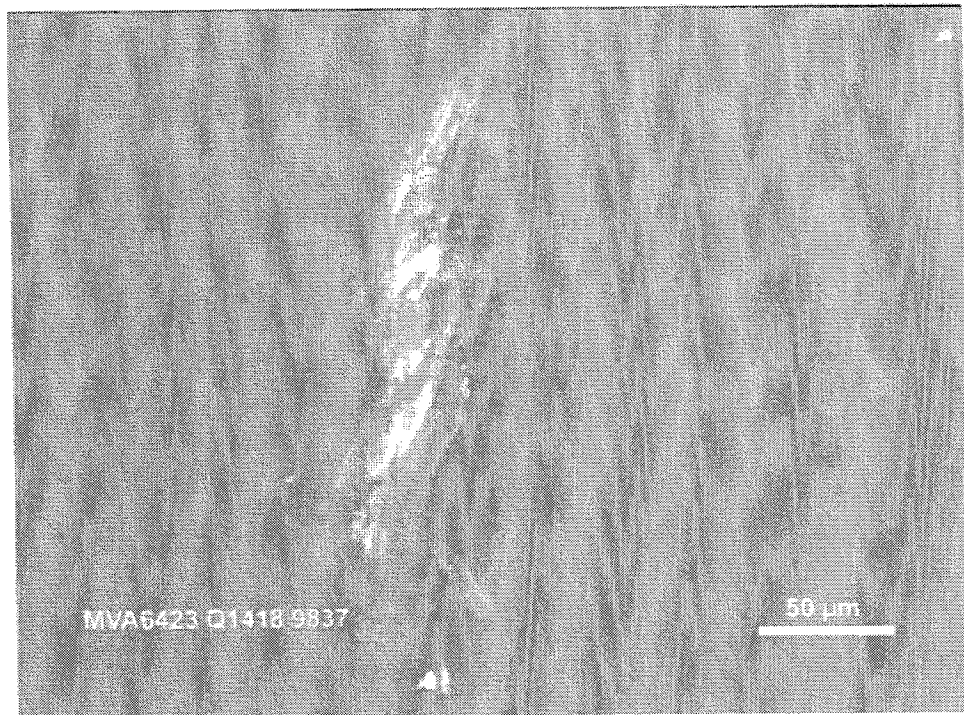
The dusts in Samples Q1418 through Q1420 have the same general appearance. They are all fine granular dusts, tan to beige in color with evident fibers. They contain vermiculite, gypsum and chrysotile asbestos (Figures 2 through 4). The particles in the dusts are consistent with normal indoor building dusts^{1,2} (including cotton and other fibers) mixed with fallout from the fireproofing (containing vermiculite, gypsum and chrysotile) that is located in the building.

Figure 3. Polarized light microscope image of a chrysotile bundle in Sample Q1418.

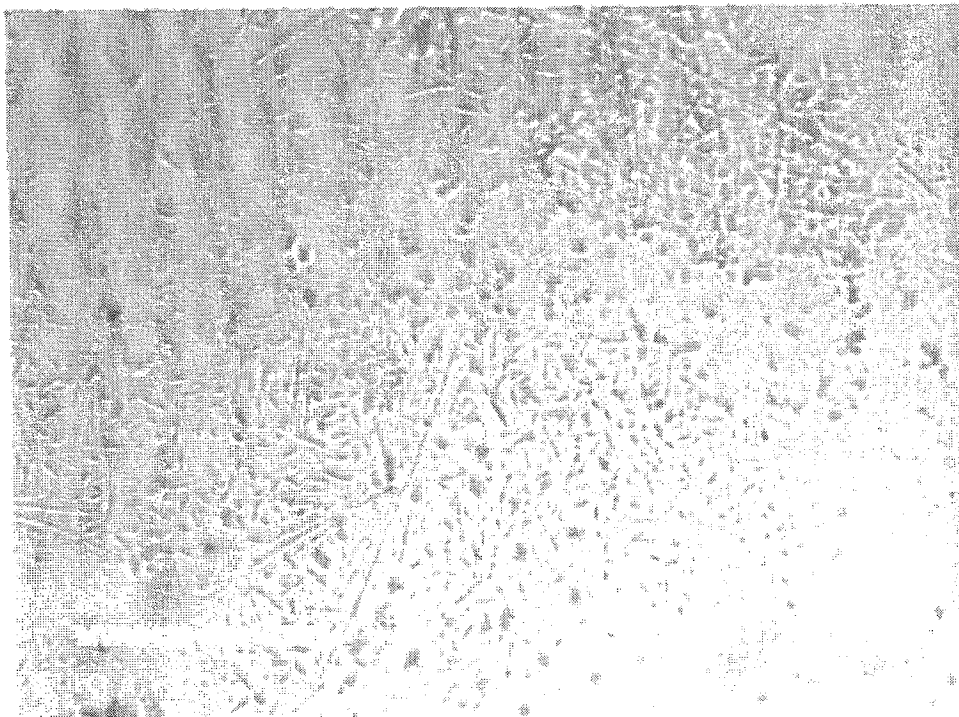
Figure 4. Polarized light microscope image of gypsum crystals in Sample Q1418.
